Degradation of *loumou* Track through Ruts in Brazzaville Western Periphery: Forms Characterization, Traffic and Rainfall Aggressiveness Analysis (Republic of Congo)

Idriss M'BOUKA MILANDOU¹ and Leonard SITOU²

Laboratory of Physical Geography, Faculty of Arts and Humanities
Marien Ngouabi University

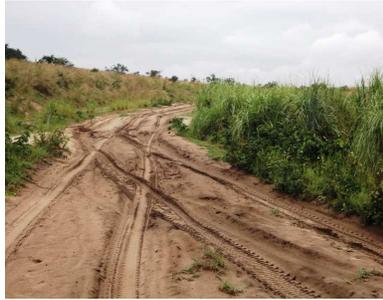
Photo 1: trace of wheels and beginning of rutting in the area of Loumou schools

According to [18], ruts are longitudinal deformations permanent at vehicles' wheel wells (Photo 1).

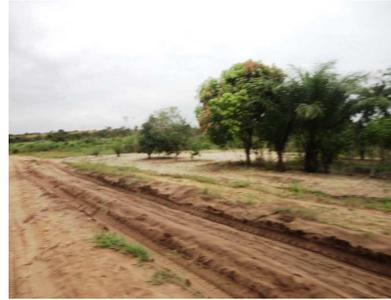
Photo 2: beginning of aggravation of the ruts at the entrance of the village Loumou

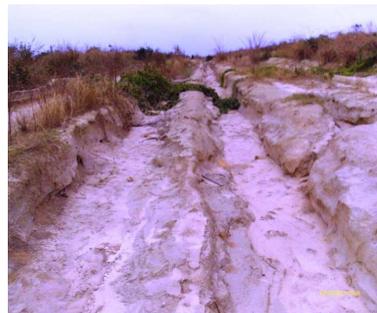
Photo 3: Evolved ruts in linear channels to Ntoba Ilélé

The relatively steep incline of more than 7% of the track at *Case Barnier* to *Ntoba Ilélé* and an average of 5% of *Ntoba Ilélé* in *Loumou*, allow runoff to quickly exploit ruts that often turn into linear ditches (Photos 3 and 4) and later in ravine (Photos 5 and 6). Hence the increased erosion on this track, which, in addition to being threatened by regressive ravines at the level of the Sadelmie-Case Barnier bituminous section, undermines the safety of the users and populations life area. According to [18], once formed the ruts hinder the vehicles lateral movements, forcing them to roll on the same furrows, which amplifies their development. In many extreme cases, their depth is such that the axles of heavy vehicles touch the ground, making the roadway impassable for light vehicles. On some tracks in the plateau of Cataractes, these ruts are the starting points of overcrowded dirt tracks, described by [25]. But if in Morocco and the USA, rutting dirt tracks blocks light vehicles, on the Sadelmie-Loumou-Nguiri axis, this phenomenon can even block all-terrain vehicles (4x4) movement (Photo 7) and even heavy goods vehicles (Photo 8), because the very compact rut between the ruts is an obstacle for the chassis of small vehicles.

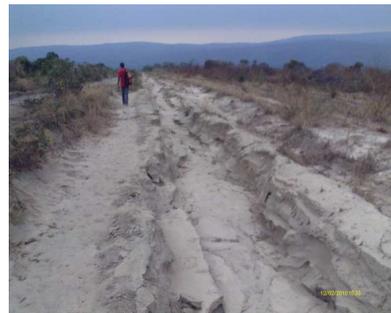
Photo 4: Evolved gutters at the exit of Case Barnier

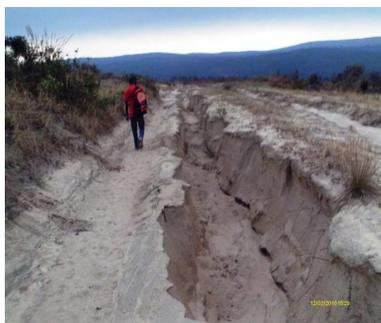
Photo 5: Evolved rut in gully near Ntoba Ilélé

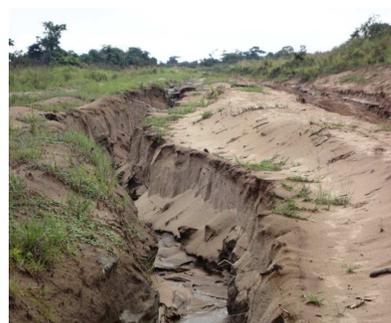
Photo 6: Evolved rut in longitudinal gully at the exit of Case Barnier

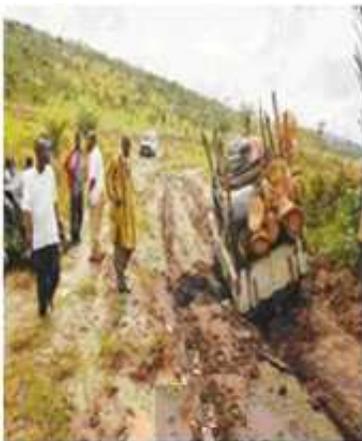
Photo 7: 4x4 vehicles blocked by the ruts towards Nguiri.
Borrowed image

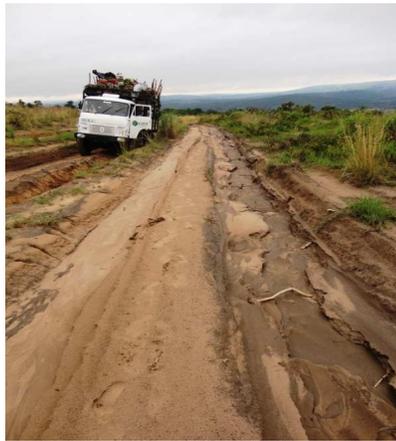
Photo 8: heavy truck in difficulty rolling due to severe ruts to Case Barnier

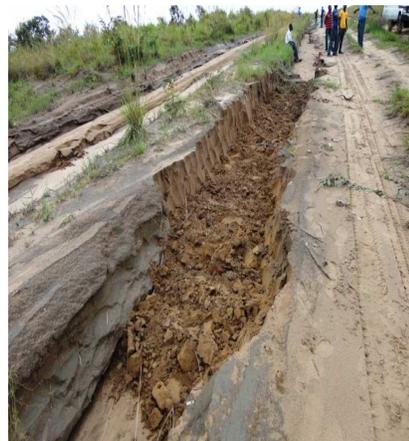
Photo 9: temptation to treat a rut to facilitate the passage of the heavy vehicle in the photo 7.

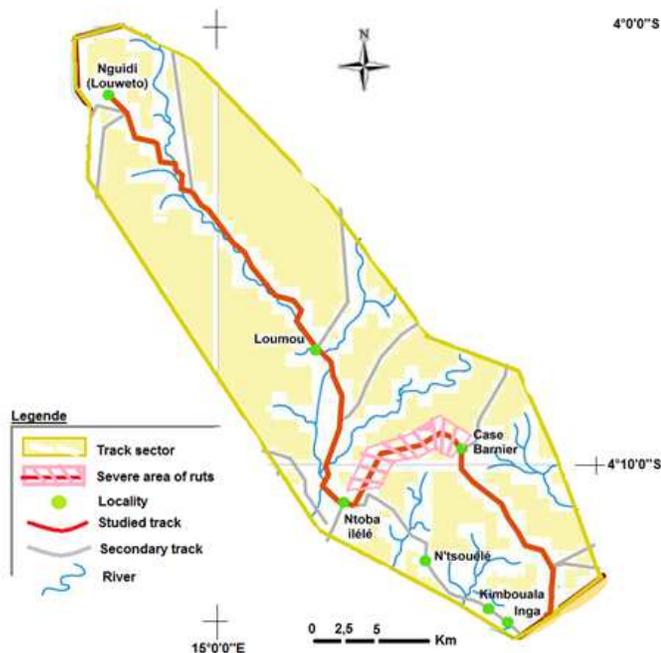
This situation is frequent in the road sector located between Case Barnier and the Ntoba Ilélé village, which stretches for nearly 10 km. This is the area most affected by rutting on this runway (Figure 2).

Faced about this impractical situation on this runway section, drivers have created deviations in the savannah, to get around the area and easily reach Ntoba Ilélé. The ruts gravity in this zone is coupled with the silting phenomena, which on the one hand is due to the geological nature of the area, dominated by sandy formations of the Tertiary, very erodible, with an erodibility index (K) between 0.35 and 0.45 t.ha.h / ha.MJ.mm [19], on the other hand, by the fine erosion that occurs upstream of the track towards the *Case Barnier* area and on sandy road slopes with gentle slopes and fairly stable thanks to the vegetation. This erosion is related to the aggressiveness traffic and rains on zone but also to anarchic occupation of the lands dedicated to the construction of the houses and to the agricultural activities.
