Conservation of Dutch Colonial Architecture Heritage On Rectorate Building of Education University of Indonesia in Bandung

Alwin Suryono^{1*}, Antariksa Sudikno², Purnama Salura³

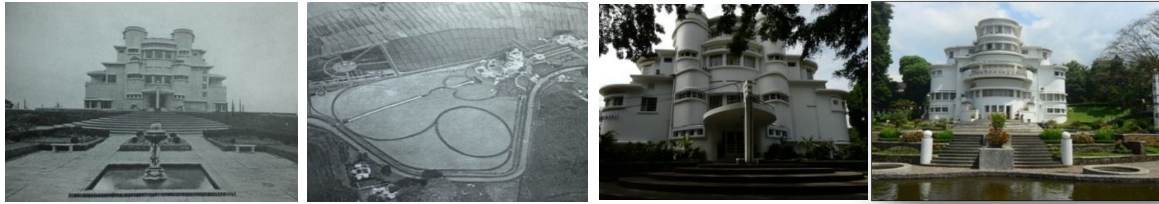
Figure 1. Cultural Significance.

Architectural significance: The architectural significance that needs to remain intact was the Europe modernity at building envelope (horizontally massive-transparent curved elements made of smooth materials, Prof. CP Wolff Schoemaker works) that still looked beautiful, sturdy, modern and comfortable (Figure 1). This architectural significance was given high grade as well.

Symbolic significance: The simple plain curve of building envelope was Europe modernity symbol, the curved form of the building was the symbol of adaptation to the site bordered by the rotated street, and building form integrated to the North-South axis was symbol of adaptation to the place/ environment (Figure 1). This symbolic significance was graded as high.

Left: North elevation of EUI's Rectory Building and North outdoor space in 1933. Centre-1: The position of the EUI's Rectory Building on its site/environment in 1933. Centre-2: North elevation of EUI's Rectory Building in 2013 (simple plain curve of building)

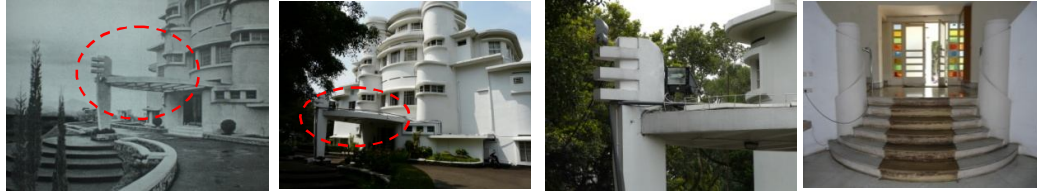
Figure 4. The Ornament

Ornament: The main entrance roof (took a leaf shape) and its pillar (took a bird head shape), door-windows (had been changed) and circular stairs and column at lobby's hall (Figure 4). Those were complicated-accurate made in 1930s, and had high artistic value and symbolic value (appreciating local nature).

Left: The entrance roof shaped leaf (made of glass and concrete frame) in 1933. Center-1: The entrance roof shaped leaf (the glass had been changed by concrete, darkened the entrance hall). Center-2: Head of the roof pillar (like bird head, still retained). Right: Curved stair and column at lobby's hall.

Ornaments as the main entrance roof (formerly transparent, and replaced to concrete slab) should be restored to its original state (transparent) so that natural light could reach the lobby hall. The head of entrance

roof pillar should be consolidated in order to withstand weather, the cord tissue trimmed and regularly maintained.

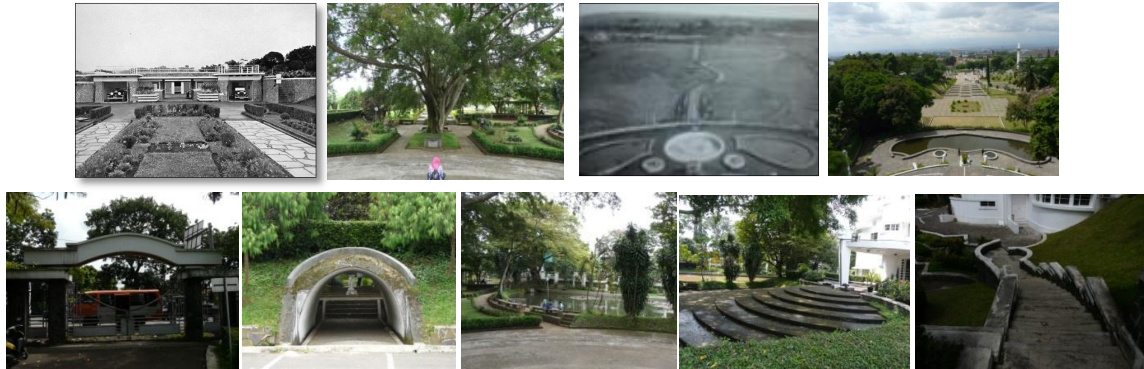
Figure 5. Exterior Space and Elements

Exterior spaces: North/front yard (garden, pool, inscription), South/backyard (garden, pavement, pool) open towards the south (Bandung city), tunnel, round stair to main entrance, graded curve path (Figure 5). All of those had well/accurately designed, and had been graded as high in architectural value and also high in symbolic value (adapting/appreciating the local nature).

Above-left: Path and park at North yard (view to Tangkuban Perahu mountain) in 1933. Above-center-1: Path and park at North yard (view was blocked by beringin tree). Above-center-2: South yard in 1933 (curved path, circled pool (original) was open towards South (Bandung City). Above-right: South yard in 2013 (pool was remain with little change, straight path) still open toward South (Bandung City). Below-left: The main gate (authentic) in 2013. Below-left-2: Tunnel (authentic). Below-center:

Exterior elements (garden, pool, inscription, pavement/path, tunnel, bench) need to be preserved and maintained regularly. The curved pattern at the back yard should be restored, as possible as it could be.
