Investigation of the Impact of Marine Algae on the Corrosion of Mild Steel

Hayden Allwright¹, Hossein Enshaei²

¹Australian Maritime College, University of Tasmania

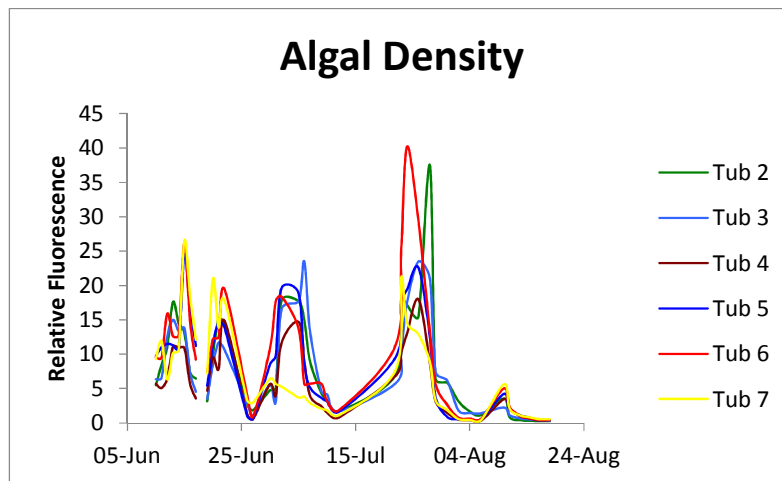
The density of the algae is presented below in Figure 1. Clearly the density followed a cyclic pattern as described above. After the algae had died in each cycle, the water was replaced completely to avoid further increasing iron concentration in the seawater. The range of fluorescence readings corresponds to algae cell densities found in coastal regions.^[21]

Figure 1: Cell density of algae presented as relative fluorescence.

From the graph it is very hard to distinguish a clear difference between the two concentrations of algae tested. It was found during each cycle that controlling the growth rate and concentration of algae was very challenging. Initially the two concentrations were set as desired; one doubles the other. From there it was observed that the tubs containing the lesser amount of algae grew faster than the tubs containing the higher concentration and during more than one cycle a tub starting with a lower concentration grew to have a higher concentration than the tubs intended to hold the higher concentration. The tubs starting with the lower concentration also held a higher concentration longer before decaying.

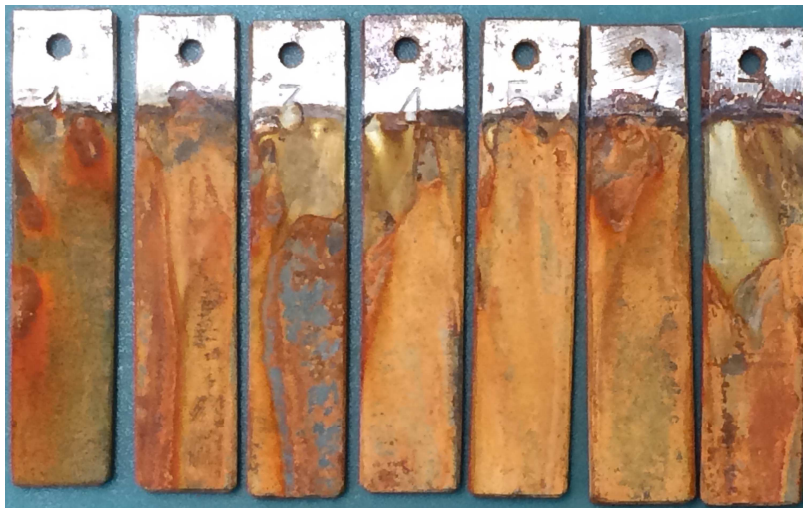
The differences in corrosion activity on the steel surfaces suggest that the algae have a physical effect on the steel and not just a chemical effect. This is shown in Figure 2 where interesting distributions of corrosion products can be observed after only 30 days. The control piece (number 1 on left) presents more extensive corrosion in three

areas with corrosion products streaking downwards. On the remaining pieces that have been exposed to algae, a very large and obvious zone of minimal corrosion can be seen on three of the pieces. These zones are the top areas of pieces 3, 4 and 7 where a green tinge can be seen in place of the reddish brown corrosion. On the other side, similar zones can be seen on pieces 5 and 6.

Figure 2: Photograph taken 9 July (30 days) showing distribution of corrosion products on steel.

It was noted by Videla and Herrera^[7] that the mucilage developed by algae and deposited on steel surfaces alters the structure and formation of a passivating film. This is definitely reflected in the figure. Mucilage has been deposited in these zones and has effectively prevented corrosion at this point in time.

It was also noted that mucilage can facilitate the forming of differential aeration cells when a patchy coverage occurs as observed in Figure 2. This occurred where there was a difference in the concentration of dissolved oxygen between two points of the same metal surface. Since the direction of the reaction was towards equilibrium, the only way that equilibrium could be approached by corrosion was reduction in concentration of oxygen where it was highest. Evidence of this is also present by the corrosion products in other areas. These are visibly more extensive than the control piece and this is to be expected. Under the mucilage biofilm the steel is shielded from the oxygen needed for corrosion to occur. In other regions the oxygen is more concentrated and a concentration cell is developed, exacerbating corrosion. The production of metal ions in these zones decreases the local pH, further increasing corrosion.

It is shown in Figure 5 that, by mass, there is a much more extensive passive film on the surface of the control steel piece. Mucilage increases dissolution of iron and its removal from the steel surface. This will reduce the capability of the steel to develop a passive film, as observed and shown to be clear in Figure 2.

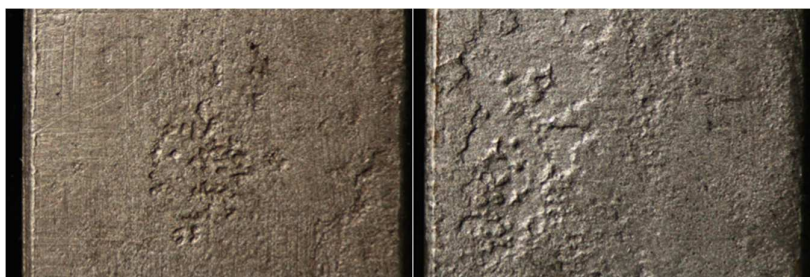
Figure 3 presents photographs taken using a stereomicroscope of the control steel piece and a piece exposed to algae. The images target the most extensive pitting on each specimen. It can be seen on the control piece (left) that the pitting has very defined sharp edges and is deep. By contrast, the pits caused by corrosion on the second piece (right) are shallower and spread more broadly over the piece. The pits also have rounded smoother edges.

Figure 3: Pitting comparison between control and steel exposed to algae.

These effects can be attributed to the spread of mucilage over the steel that smooths the corrosion process in certain zones, leading to a larger area corroding to a shallower depth for the same amount of steel removed.

The deep pitting in the control piece is typical of pitting corrosion where a greater distance to the centre of the pit makes it anodic.^[9]

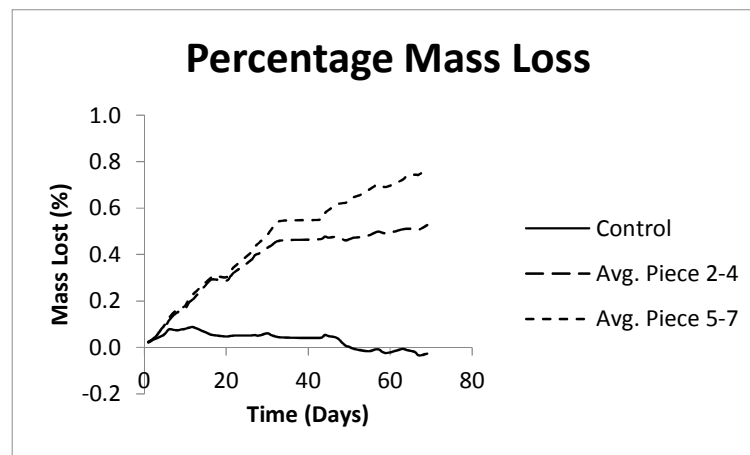
Figure 4 presents the decrease in mass of the steel specimens over time as a percentage of their original mass. The mean at each instance of time has been taken for the replicated conditions. This does not present data for after the corrosion products were removed from the steel.

Figure 4: Mass loss in steel specimens as percentage of original mass.

The figure shows that over time the control piece lost mass initially before settling and a mass increase was observed. This is opposite to the expected mass decrease. As the steel is corroded and iron atoms are removed into the solution the mass should decrease. However the formation of corrosion products on the surface will cause a mass increase. As the iron atoms bond with oxygen atoms the mass increases. If the total mass of oxygen atoms bonding to iron is greater than the mass of iron atoms entering the solution then the mass of the steel piece will increase.

Conversely, the tubs containing algae showed a continual decrease in mass that followed a logarithmic pattern. The tubs containing the higher algae concentration began to clearly cause more mass loss than the lower concentration after 30 days. The mass loss in the tubs containing the greater concentration of algae is only just beginning to trend away from a linear curve towards a logarithmic function after 70 days. This demonstrates that a higher concentration of algae is positively correlated with a greater rate of mass loss in steel suffering from

corrosion. It is very apparent that the tubs containing algae caused a much greater mass loss than the control specimen in filtered seawater.

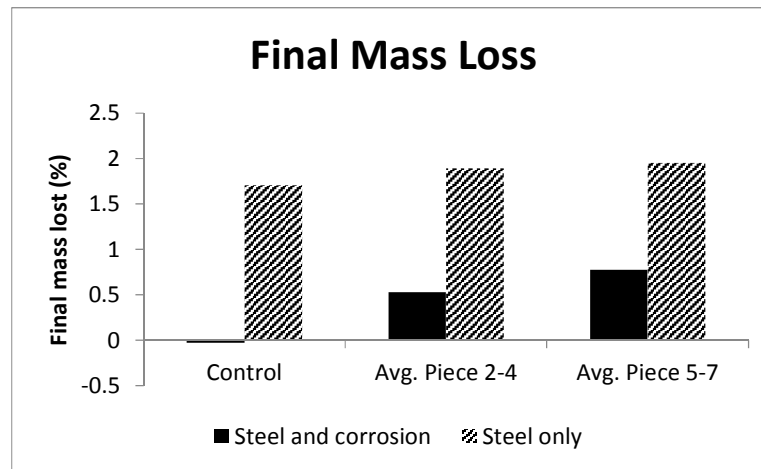
The removal of the corrosion products at the end of the testing period revealed some interesting results that can be seen in Figure 5. The figure presents the overall percentage decrease in mass for the steel specimens both before and after the corrosion had been removed from the initial condition.

Figure 5: Final mass loss as a percentage of original mass.

The consequence of the pitting differences is considerable. The results in Figure 5 show that a similar amount of mass loss occurred on all steel pieces. In the case of the control piece, much of this was due to pitting corrosion whereas in the pieces immersed in algae this mass loss was more reminiscent of general corrosion. The larger area of general corrosion means that the thickness losses will be less than for pitting corrosion for the same amount of steel removed. According to the survey standards of such societies as Det Norske Veritas^[10] and Lloyd's Register^[22], thickness diminution is the standard used to determine material wear out due to corrosion. Hence the pitting corrosion present in the control piece can be considered as more harmful.

After the removal of corrosion products from the steel specimens, it was found that the mass decreased in all as expected. A greater decrease in mass was recorded in the steel specimens exposed to the algae and an increasing amount of algae yielded a greater decrease in mass, indicating increased corrosion. However, the observed difference is actually small: one quarter of a percent is the difference between the control and higher algae concentration condition after 70 days of exposure. This is in stark contrast to the mass removed before corrosion product removal.

The difference between the two columns of data is interesting; it represents the mass of corrosion products on the specimens as a percentage of their original mass. It can be seen that there is a very large difference for the control specimen; this means that there was much more corrosion attached to this piece of steel. For the two conditions of algae concentration tested, it can be seen that the difference is less than the control and lessens as the concentration of algae is increased. This means that the presence of algae is negatively correlated to the amount of corrosion products attached to the steel specimen. This can be expected to restrict the potential for a passivating film to develop over the surface of the steel, leading to increased corrosion.
